JOHN WAYNE MARINA – Property Condition Assessment

March 2019

Reid Middleton

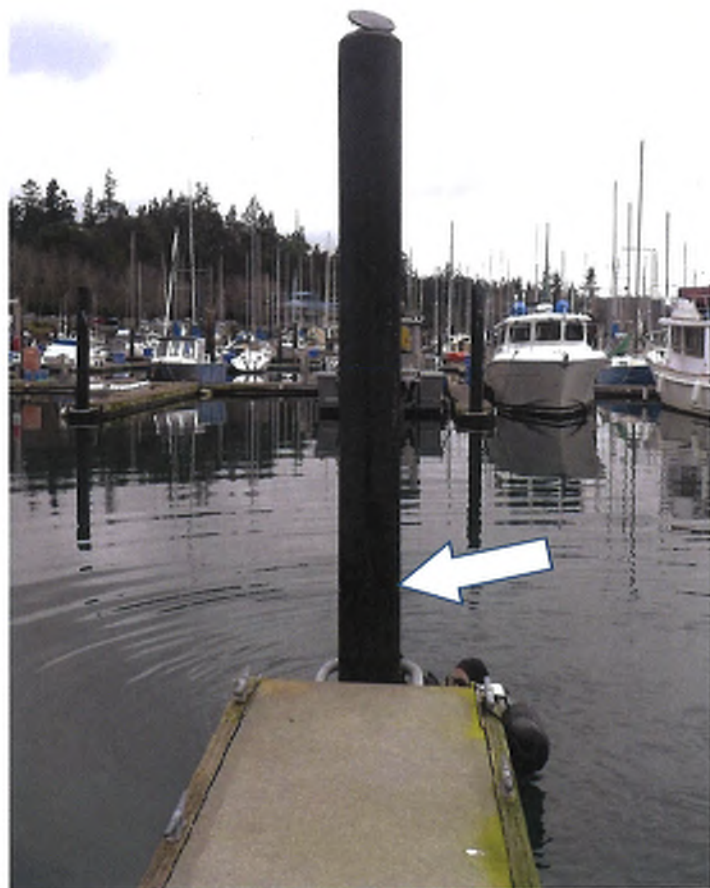
PHOTO No. 2: Float B, Pile No. B-9 –
Note the diver inspecting
the composite float
anchor pile. Also note the
displaced cap at the top
of the pile and the arrow
approximately two feet
above the water surface
where a horizontal cut
was found in the outer
recycled plastic casing, or
possible splice. Also
refer to Photos No. 3
and 4.

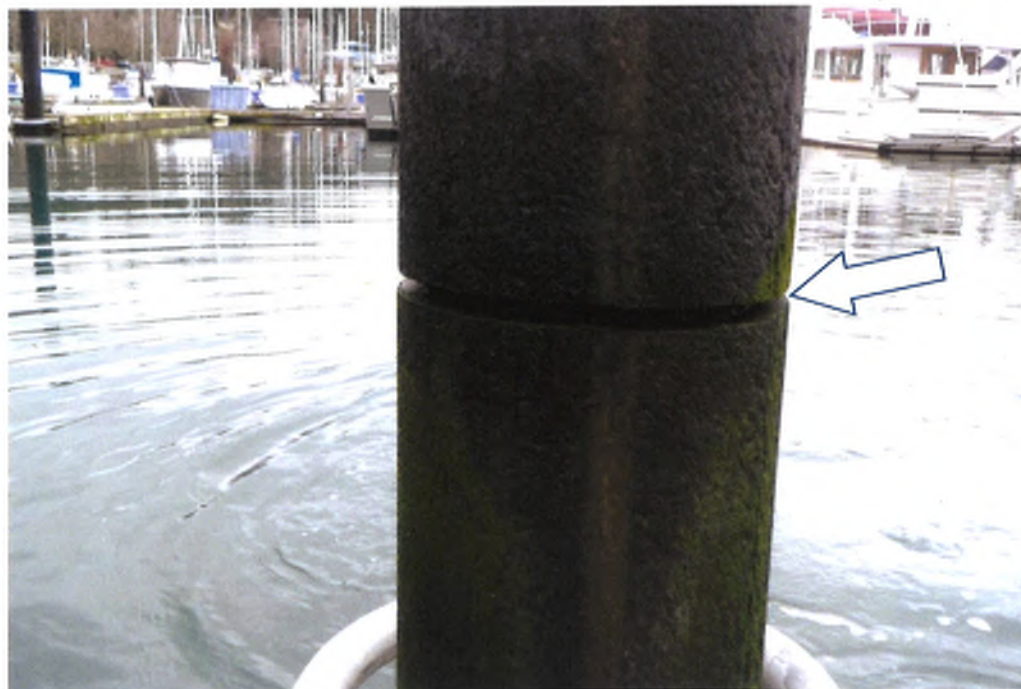
PHOTO No. 3: Float B, Pile No. B-9 – Note the approximate ½ inch cut or gap between the upper and lower sections of the outer plastic casing. It appears that this is a splice between sections of the composite pile.

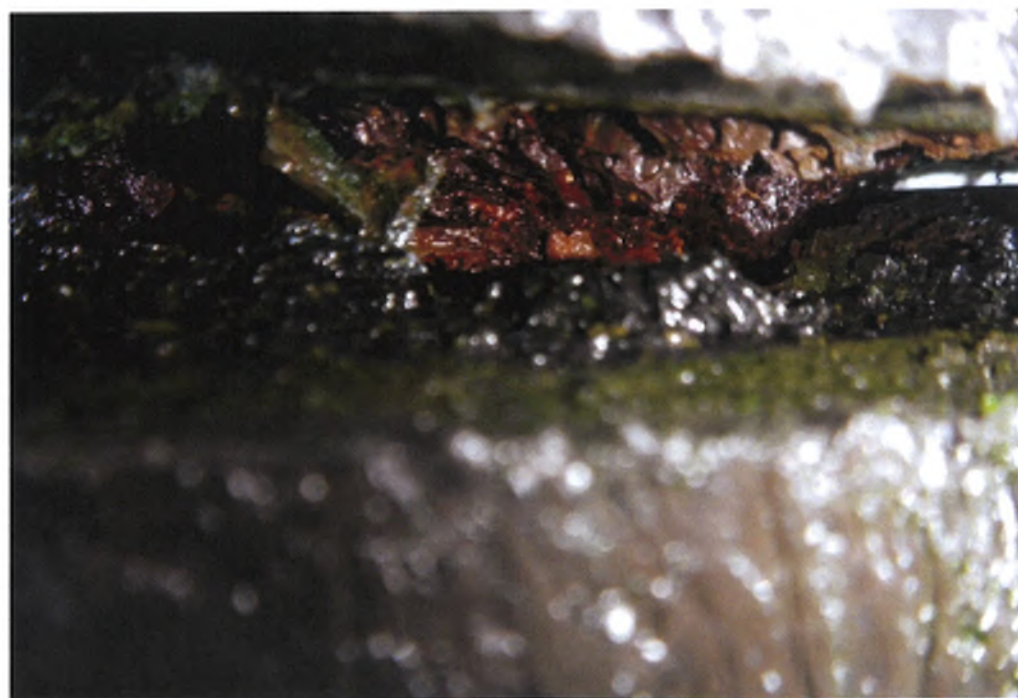
PHOTO No. 4: Float B, Pile No. B-9, Close Up – Note the corrosion on the exposed inner steel core of the composite pile. The surfaces of the plastic casing were noted to have a "finished" appearance. Evidence that this was a cut in the plastic supporting the possibility that this is a splice location.

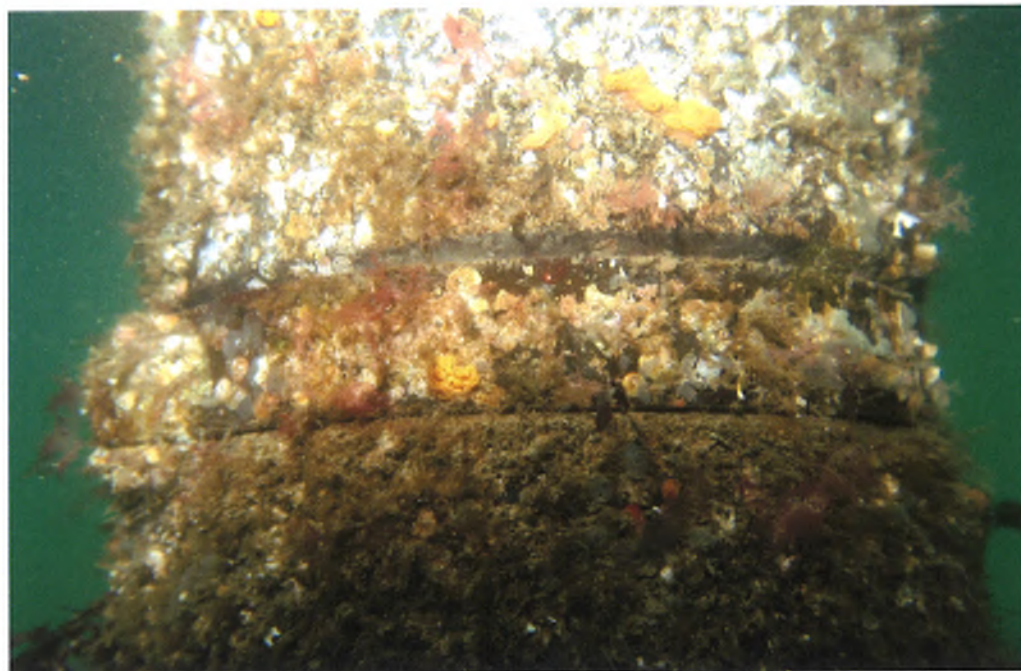
PHOTO No. 5: Float B, Pile No. B-18 - Note the band around this composite pile in the submerged zone. The band appears to be manufactured of recycled plastic and is assumed to cover a splice where drill string sections have been screwed together. No evidence of any rust bleeding was noted.

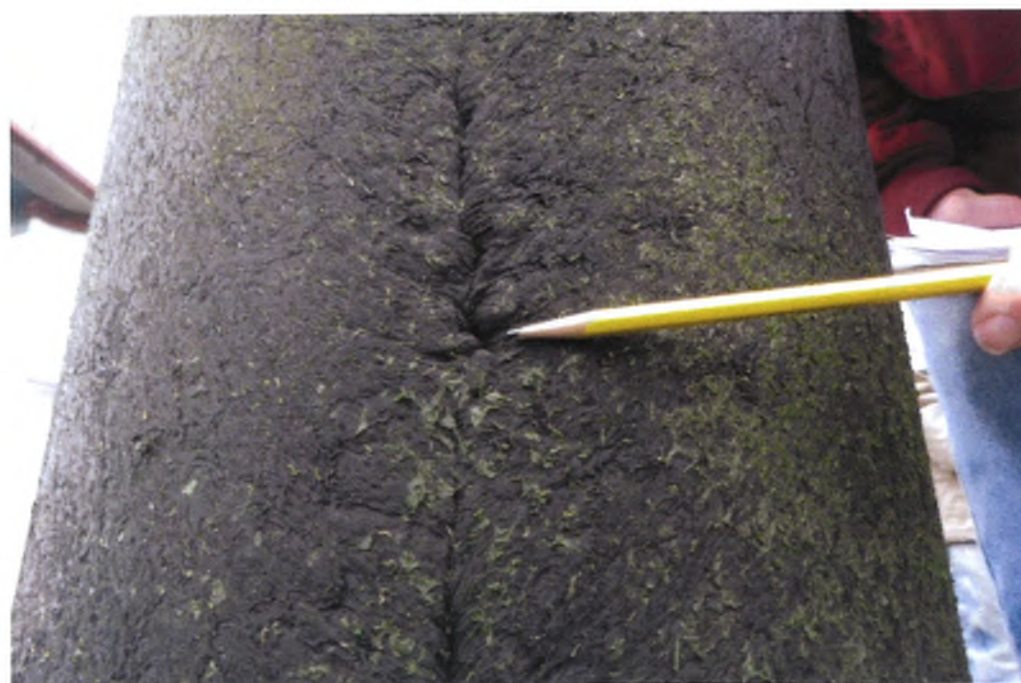
PHOTO No. 6: Float B, Pile No. B-17 - Note the vertical seem in the outer plastic casing on this composite pile. Several piles were noted to have vertical anomalies that on close inspection were found to be what appears to be a seem which developed during manufacture.

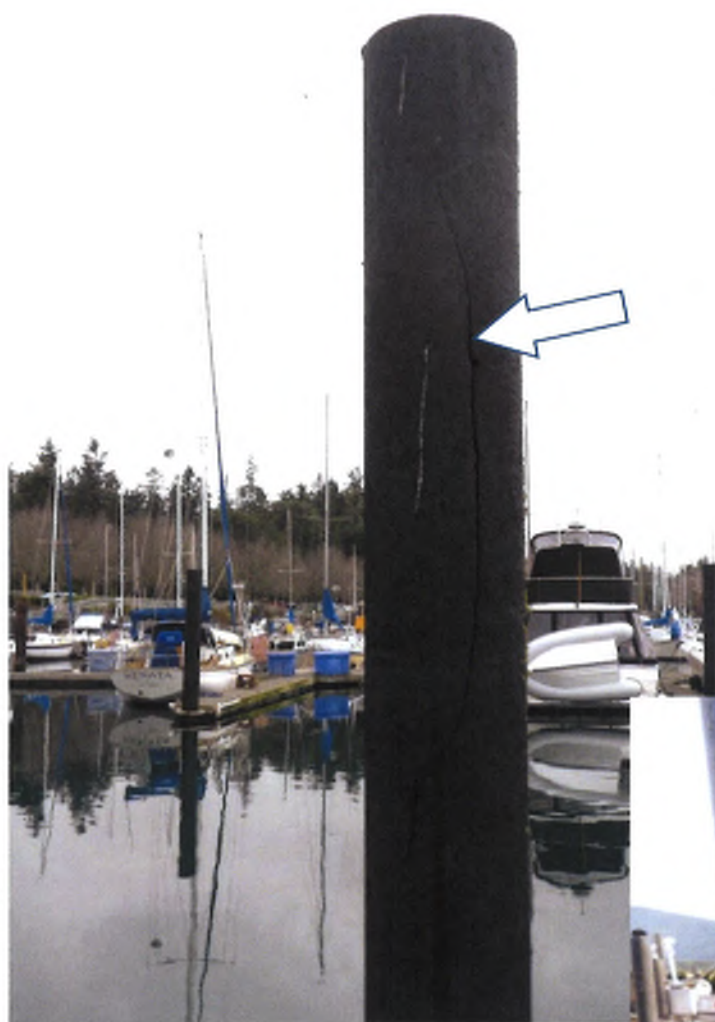
PHOTO No. 7: Float B, Pile No. B-5 – Note the approximate six foot long vertical crack in the outer plastic casing on this composite pile. No evidence of similar cracking was found below water.

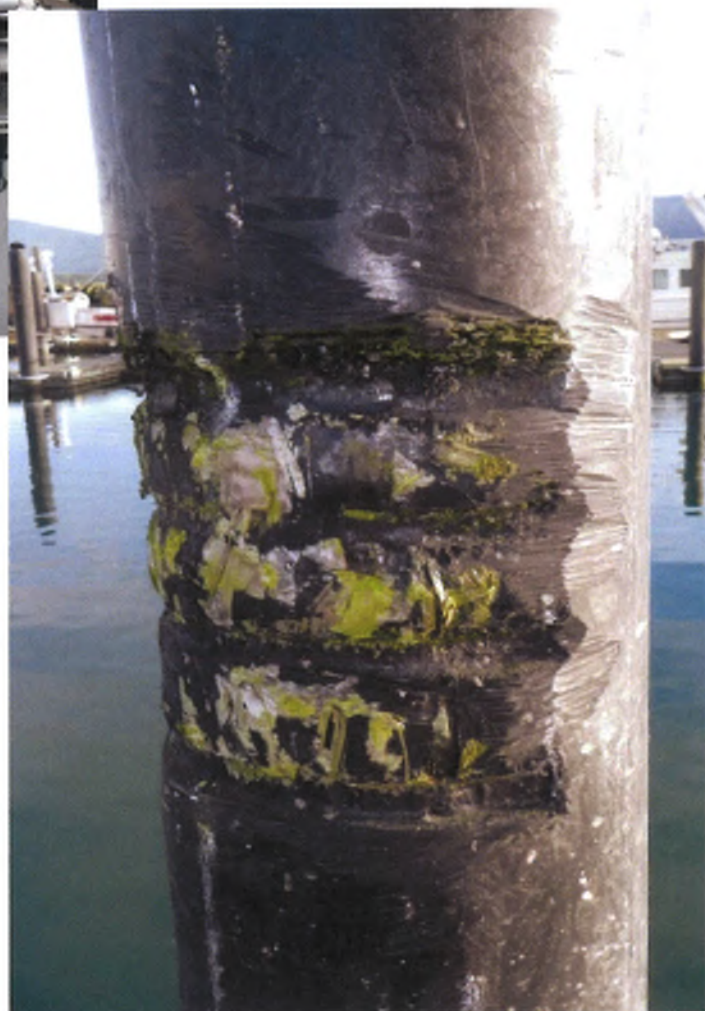
PHOTO No. 8: Float C, Pile No. C-10 – Note the mechanical abrasion damage to this pile in the splash zone. No evidence of perforation of the outer plastic casing or visible evidence of corrosion or rust was found associated with this area. Inspection of the pile below water did not identify any damage or deterioration.

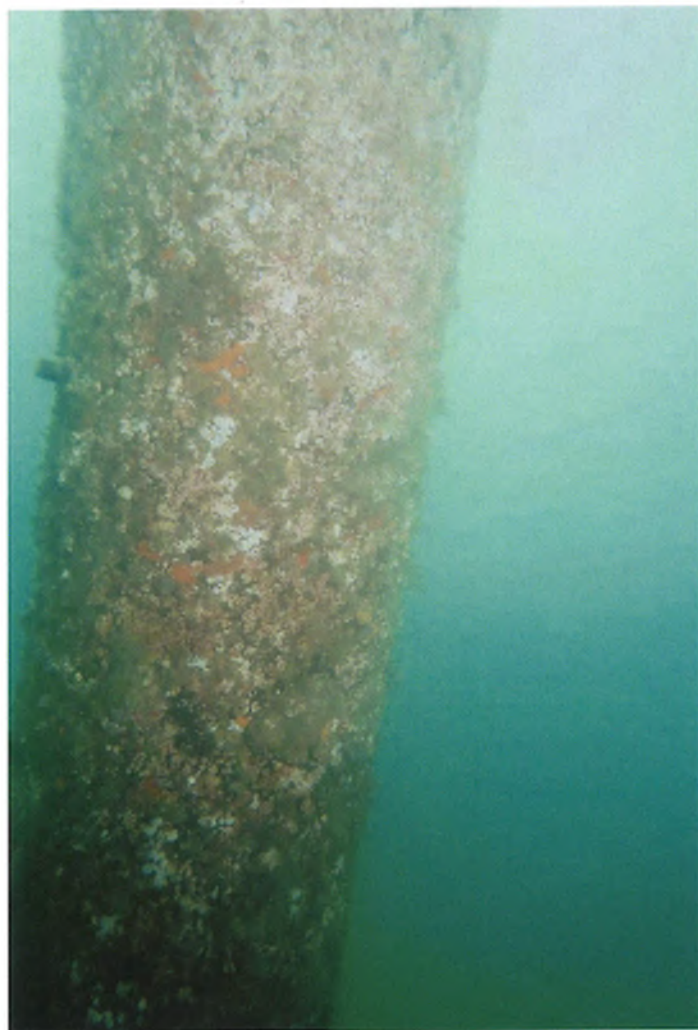
PHOTO No. 9: Float C, Pile No. C-14 – Note the light to moderate marine fouling on this creosote treated timber pile. This was found to be typical of the growth on the piles from the intertidal zone to the mudline. Inspection found this pile to be in good condition below water.

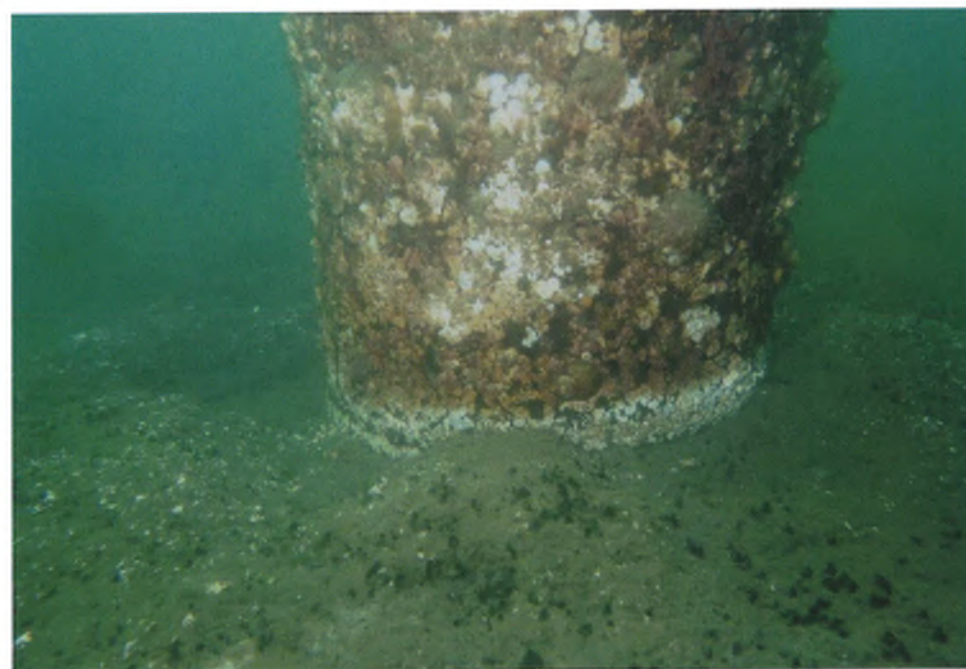
PHOTO No. 10:
Float C, Pile No. C-14 – Note the good condition of the timber pile at the mudline and the sandy-silty composition of the mudline.

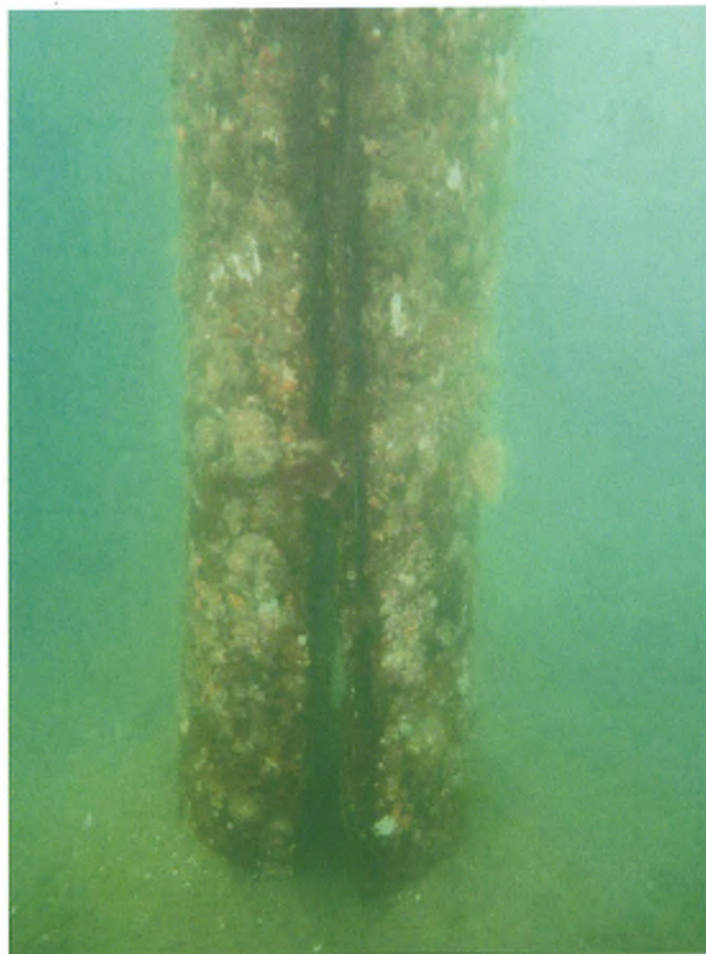
PHOTO No. 11: Float C, Pile No. C-12 – Inspection found this timber pile to be split from the mudline up approximately 7 feet. The cause of the damage is uncertain but appears to have occurred during original pile driving where the tip may have encountered a buried rock or other hard item.

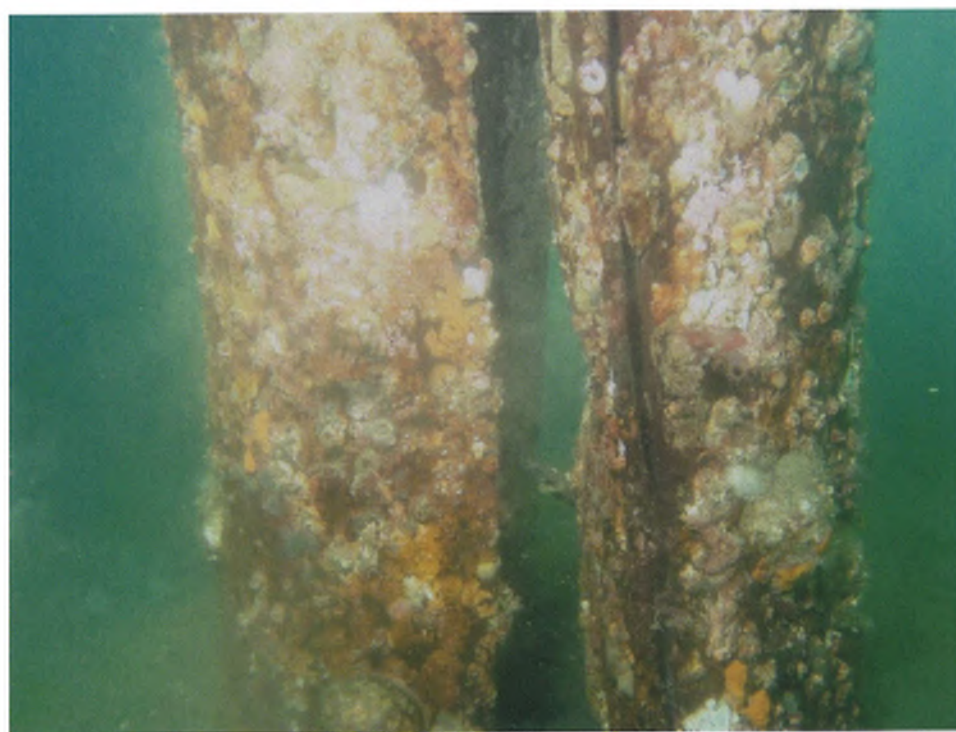
PHOTO No. 12:
Float C, Pile No. C-12, Close-up - Access to the internal core was limited, however, investigation found no apparent evidence of marine borer activity.

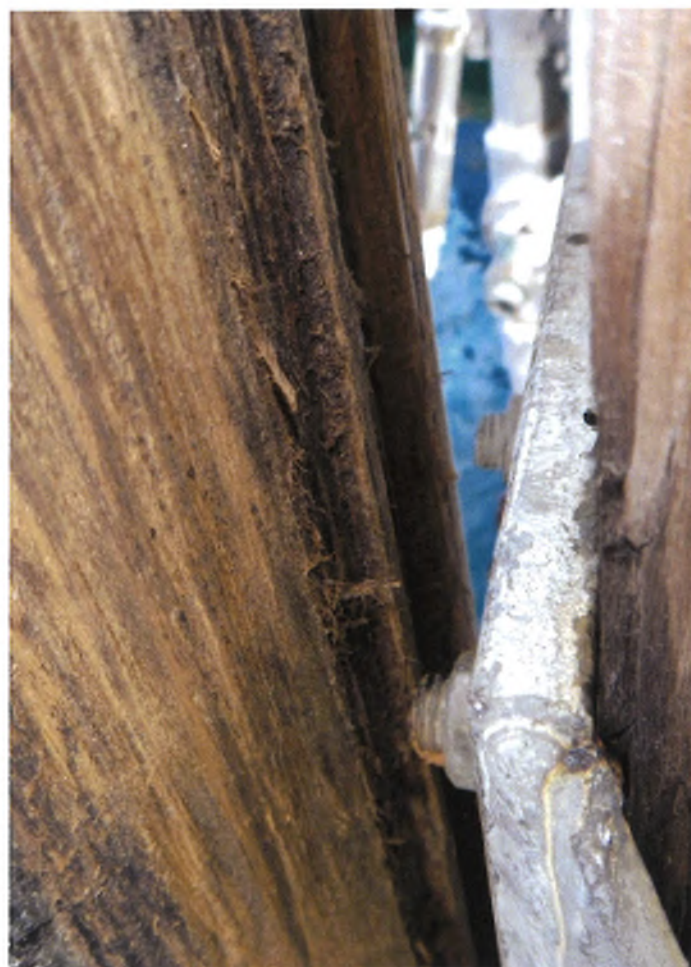
PHOTO No. 13: Float F, Pile No. F-13 – Note the mechanical scoring of the pile by the galvanized bolt in this steel stanchion bracket. The damage was estimated at approximately 5% loss and extends into the intertidal zone below water.

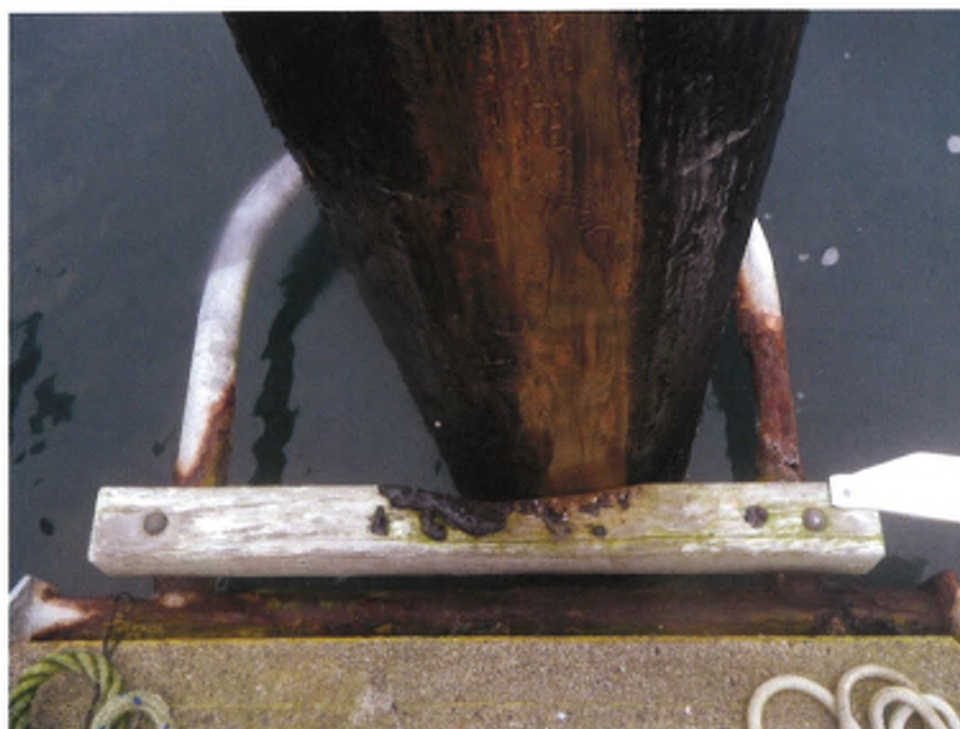
PHOTO No. 14:
Float H, Pile No. H-28 – Inspection noted a number of timber piles which have sustained this type of abrasion damage in the intertidal zone. Also note the heavy corrosion and perforation of the galvanized restraint hoop at this location. Several of the hoops were noted to have sustained extensive corrosive and section loss.

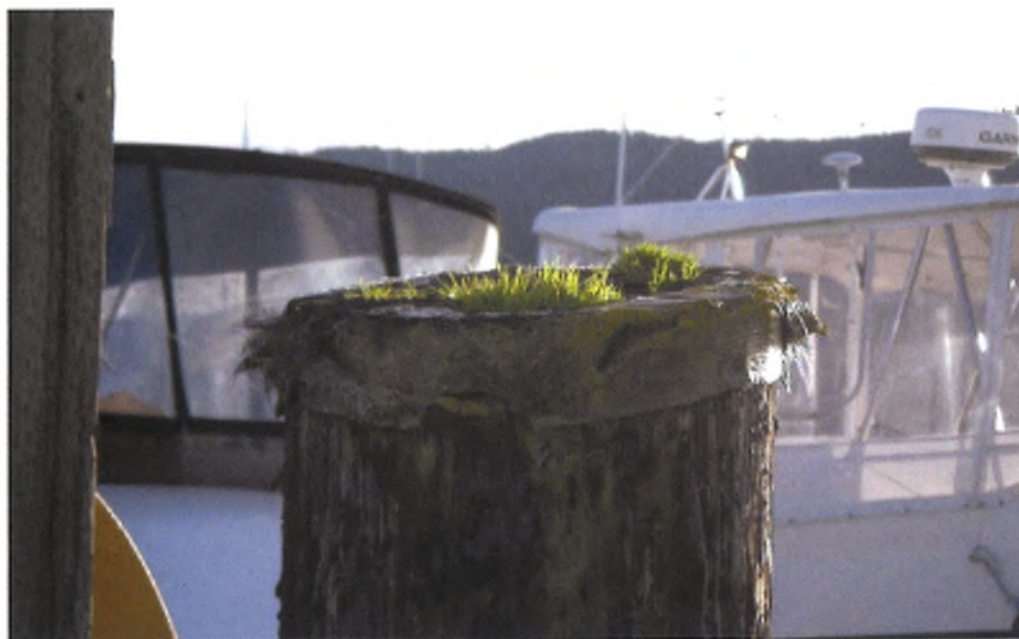
PHOTO No. 15: Float C, Pile No. C-12 – Note the damaged fabric pile cover and the fungal cavity and vegetation evident in this pile top. Several piles were noted to have similar damage where in the fabric covers have been damaged allowing moisture to penetrate into the untreated core of the pile resulted in extensive fungal decay.

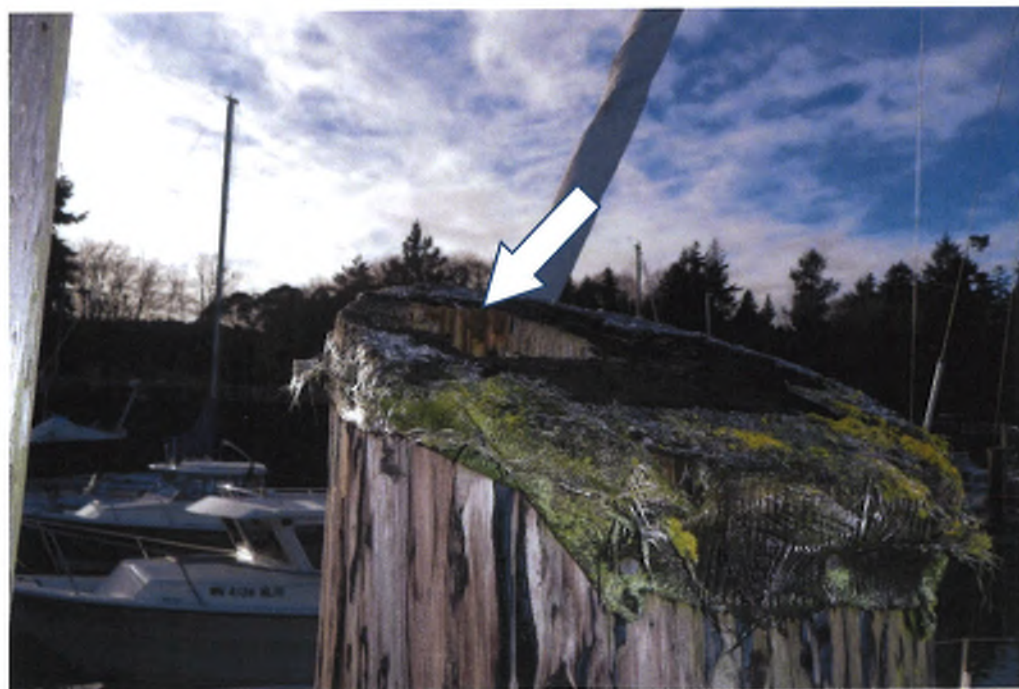
PHOTO No. 16: Float D, Pile No. D-7 - Note the damaged fabric cover and the fungal cavity evident in the top of the pile.

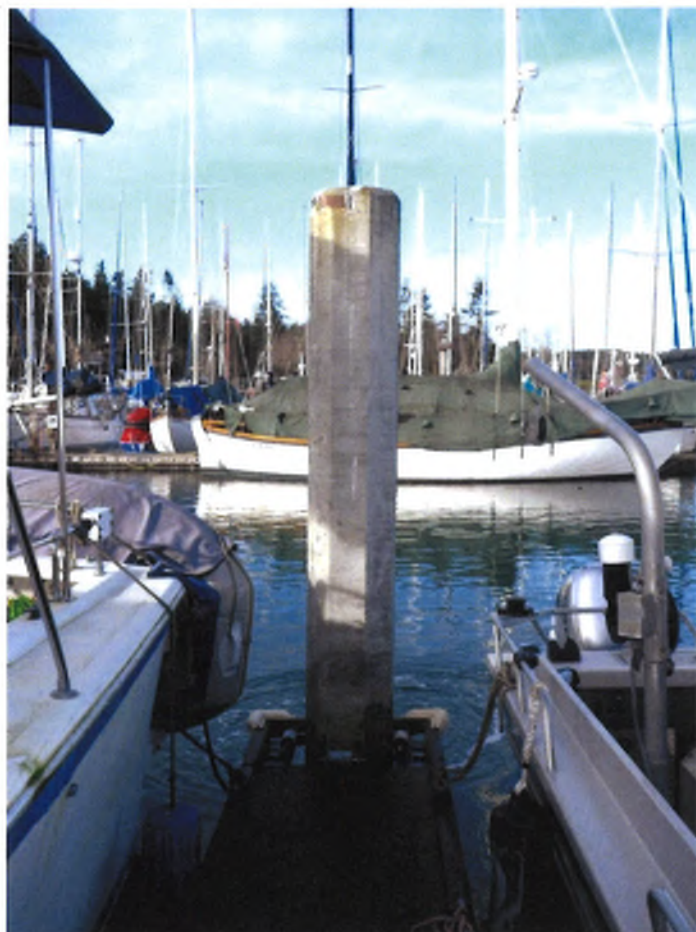
PHOTO No. 17: Float F, Pile No. F-18 – Note the good condition of the octagonal pre-stressed concrete float anchor pile. No evidence of significant damage or defect was found below water.

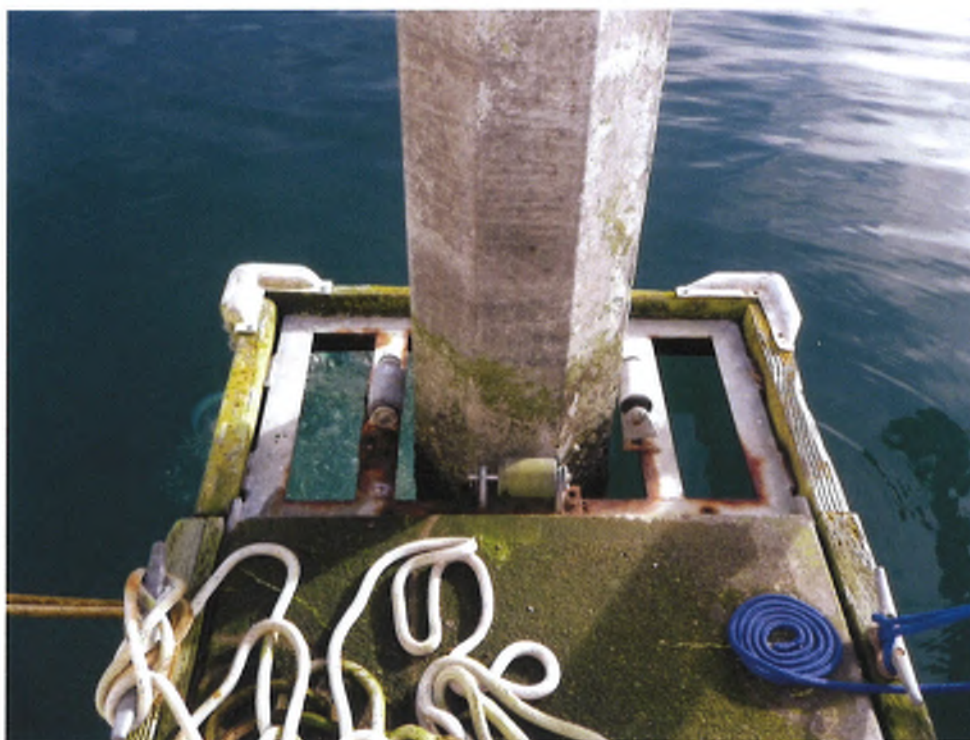
PHOTO No. 18:
Float F, Pile No. F-24 – Note the good condition of this concrete float anchor pile in the upper intertidal and splash zone. Also note the corrosion of the roller assembly and restraint hoop.

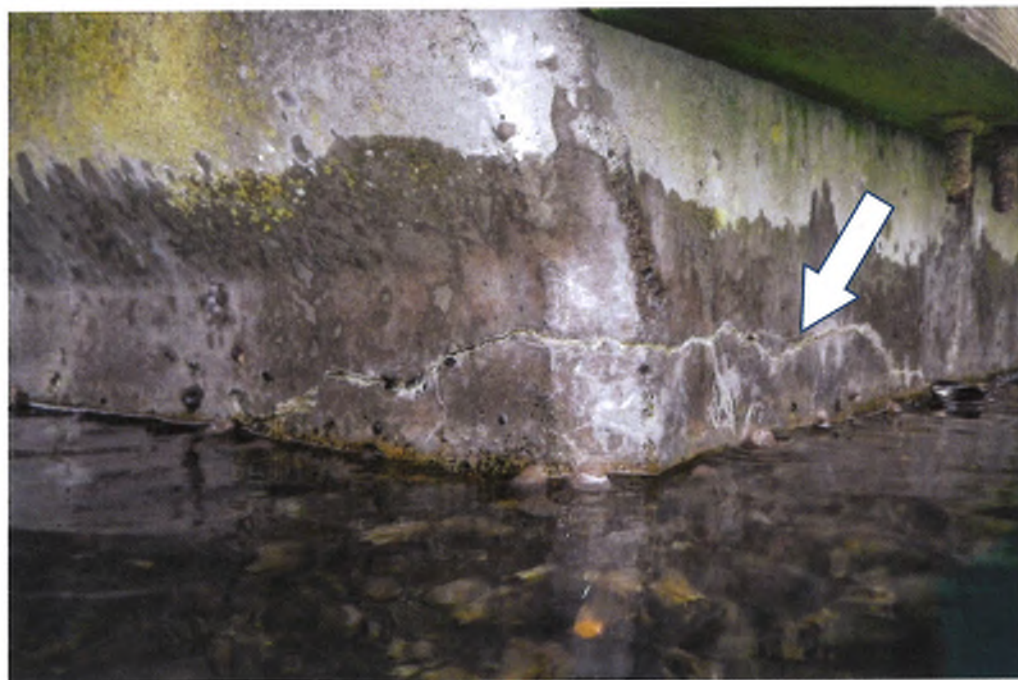
PHOTO No. 19: Float G, Concrete Pontoon At Pile No. G-11 – Note the minor horizontal cracking across the corner of the pontoon. Also note the marine fouling below water on the sides of the floats which was found to be typical of the fouling found on the pontoons throughout the marina.

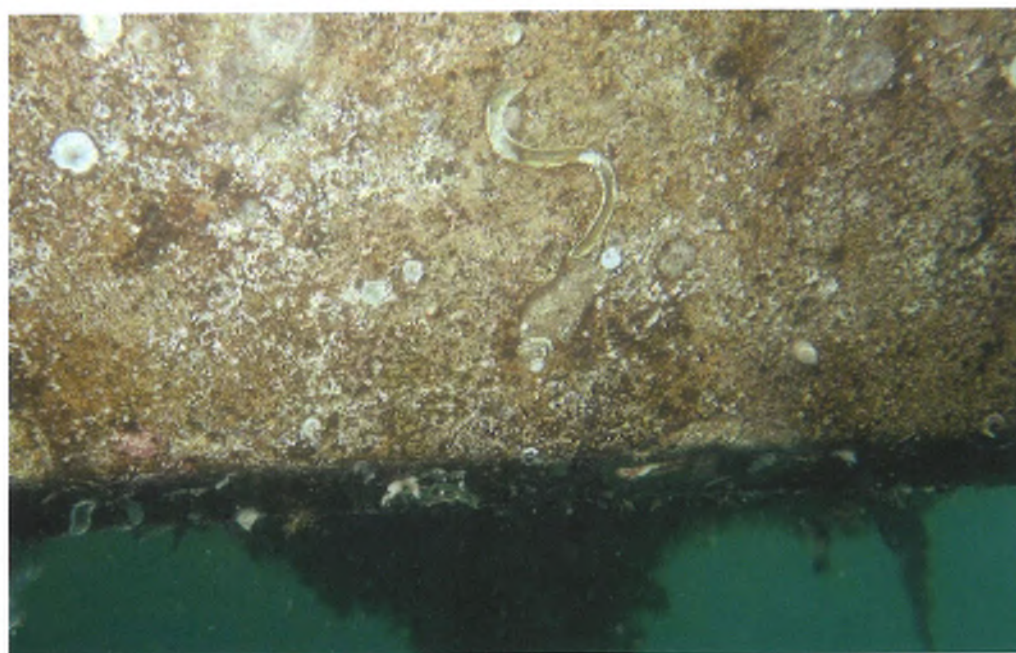
PHOTO No. 20: Float G, Concrete Pontoon Near Pile No. G-7 – Note the good condition of the concrete surface in this area of Level II cleaning which has removed the marine fouling. This was found to be typical of the submerged concrete surfaces in areas of cleaning.

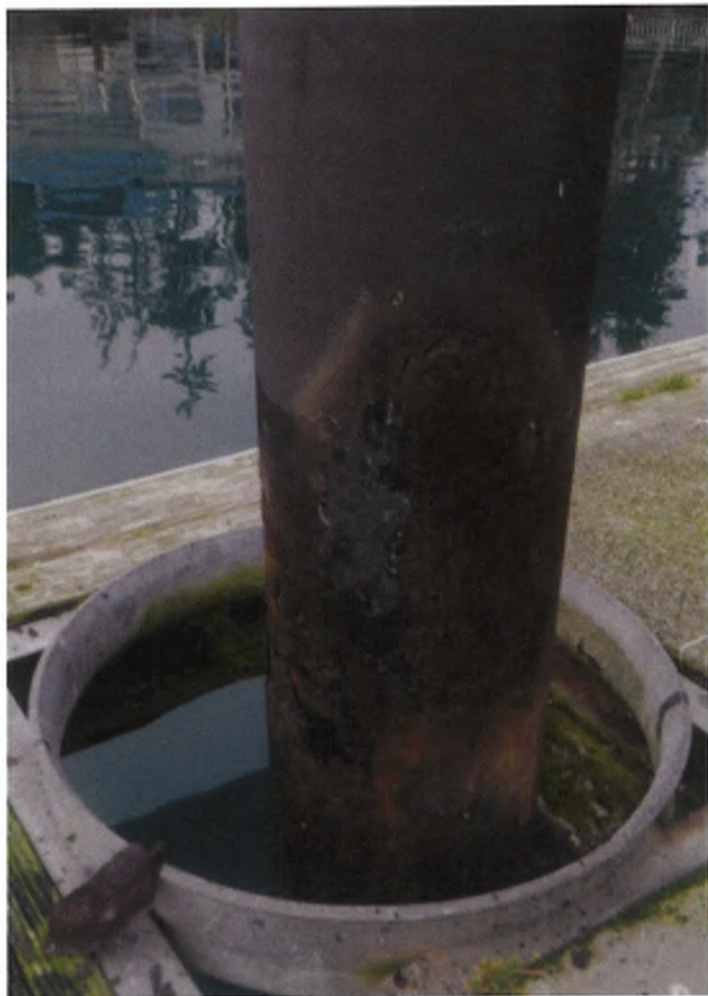
PHOTO No. 21: Fuel Float, Pile No. FF-7 – Note the black painted coating visible from the splash zone (i.e. above the corrosive scale) to the top of the pile. Also note the heavy surface corrosion and scale evident in the upper intertidal zone which was found to extend to the mudline on the pile.

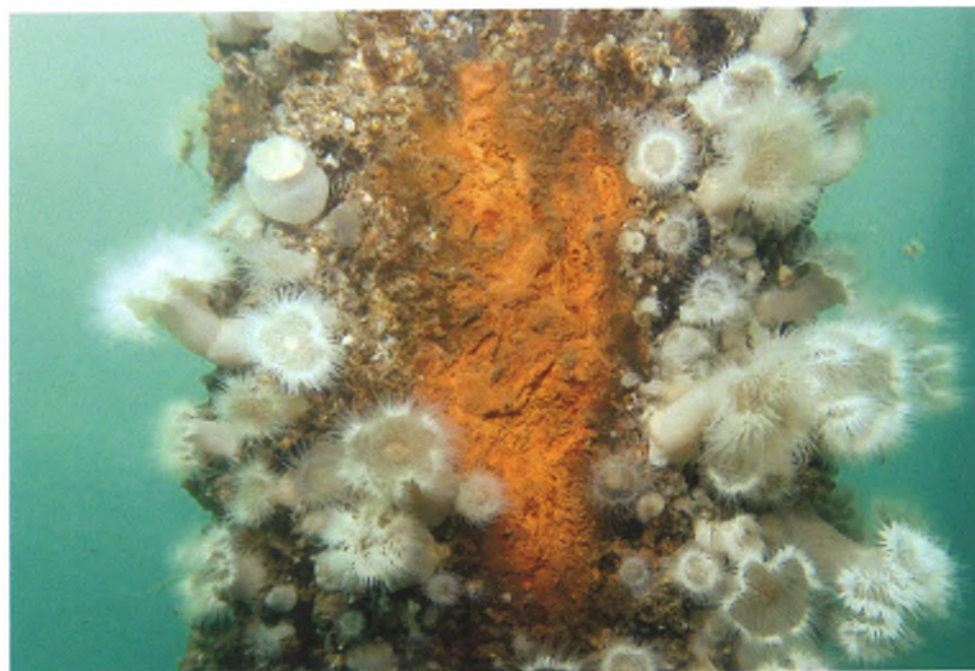
PHOTO No. 22: Fuel Float, Pile No. FF- 7 - Note the area of bright orange corrosion evident at this location where the fouling has been removed in the submerged zone. Further cleaning of the corrosive scale found several areas of perforation at various elevations.

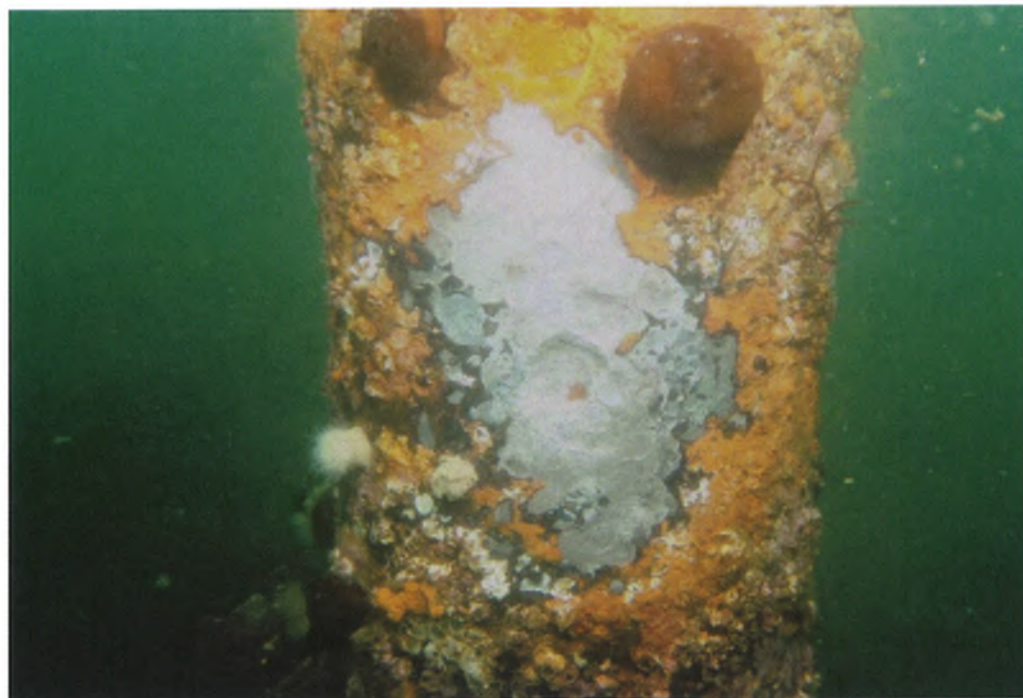
PHOTO No. 23: Fuel Float, Pile No. FF-7 – Note the generalized corrosion on the pile. This condition was found to be typical throughout the submerged zone. Also note the rough appearance of the steel in the area of Level II cleaning. Close examination also noted moderate to heavy pitting of the steel.

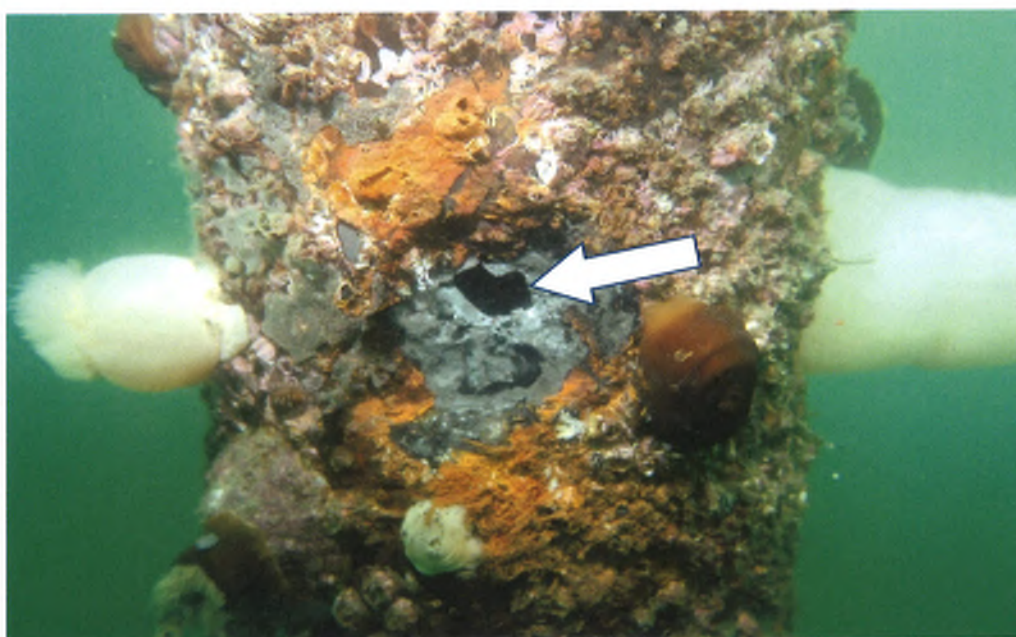
PHOTO No. 24: Fuel Float, Pile No. FF-7 – Note the approximate 2 inch diameter perforation through the side wall of this steel pipe pile in the area of Level II cleaning. Several elevations of perforation were noted along the submerged length of the pile.

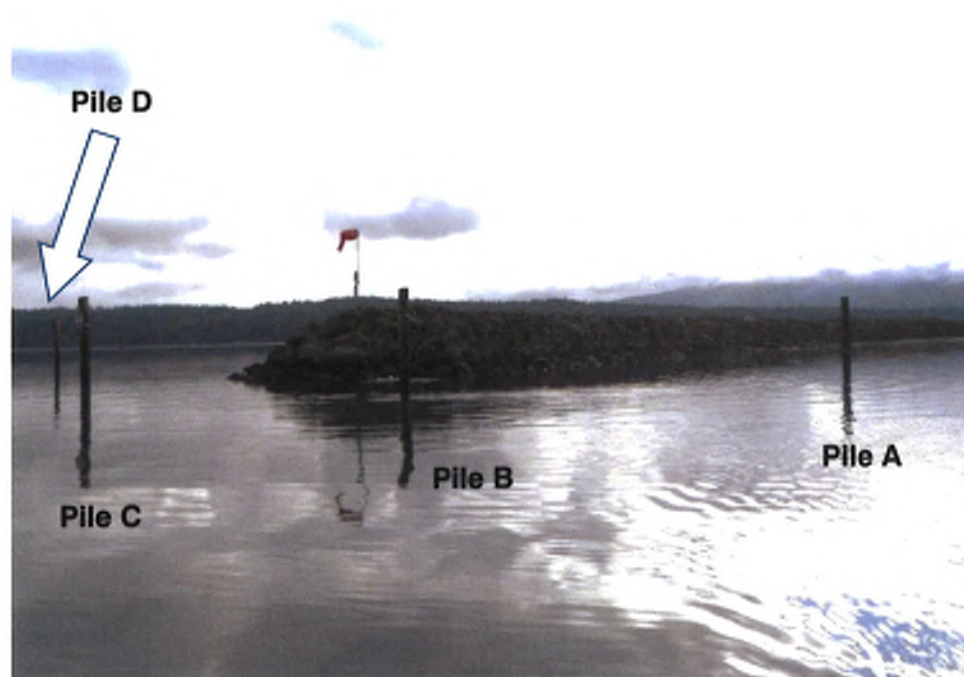
PHOTO No. 25:

Marina Entrance, Looking East – Note the western end of the rip rap Breakwater and the four Breakwater fender/guide piles. Pile A is a steel pipe pile. Piles B, C and D were noted to be creosote treated timber piling.

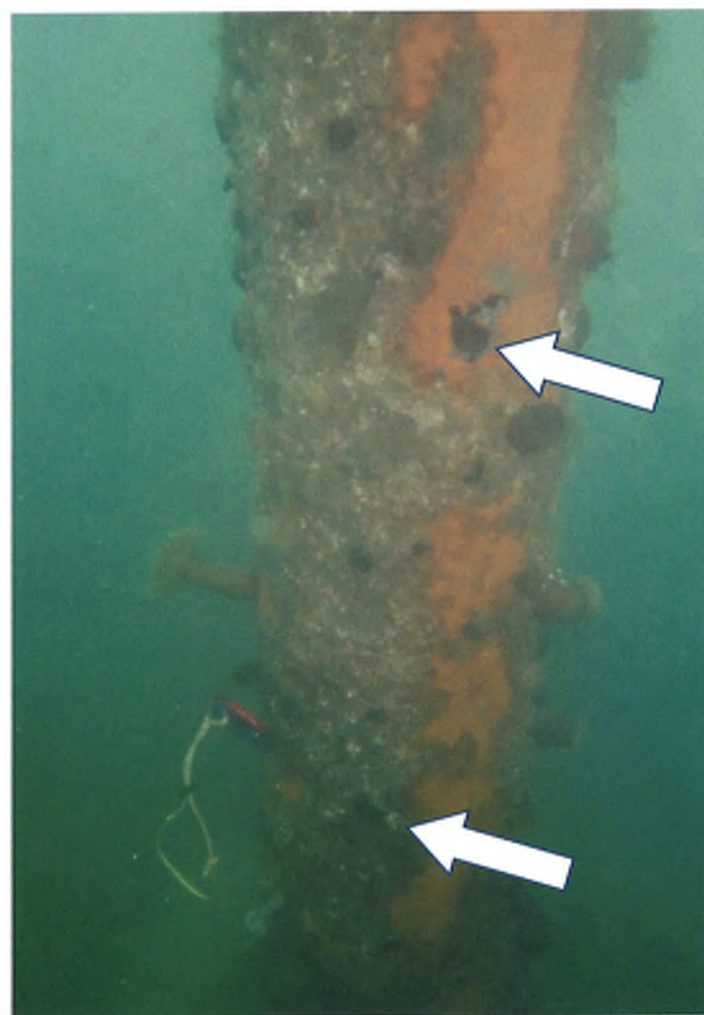
PHOTO No. 26:

Breakwater, Pile A – Inspection of this steel pipe pile found that it was apparently uncoated, without any cathodic protection. Note the areas of orange, active corrosion and the arrows indicating two locations of perforation through the side wall of the pile. A red handled inspection screwdriver has been inserted in the lower perforation.

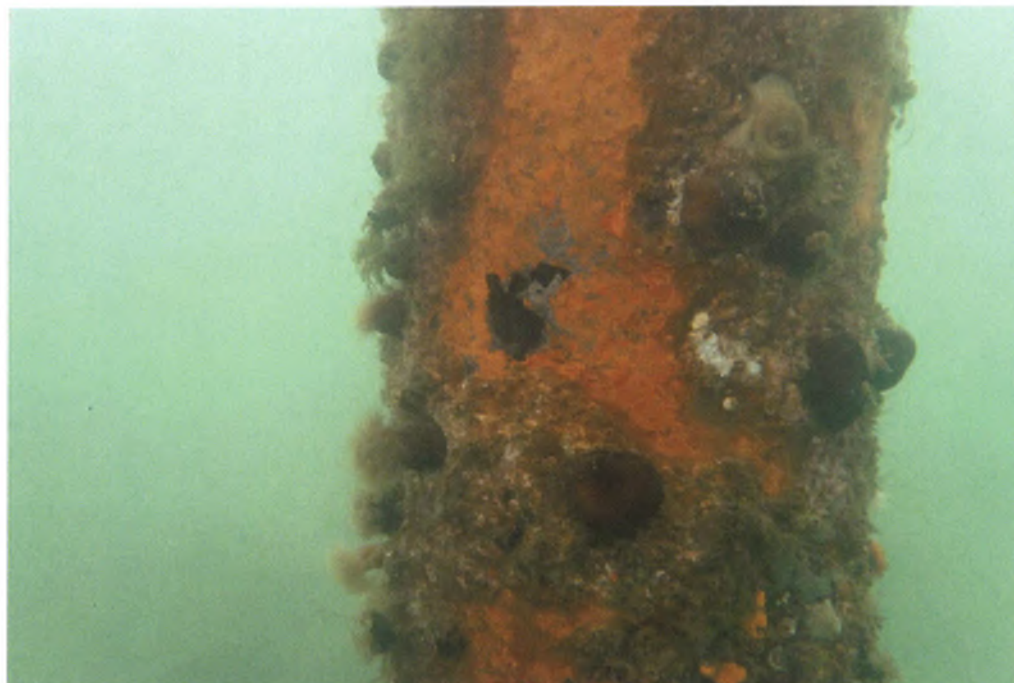
PHOTO No. 27: Breakwater, Pile A, Close-up – Note the active corrosion and the approximate 3 inch diameter perforation identified in this pile in the submerged zone.

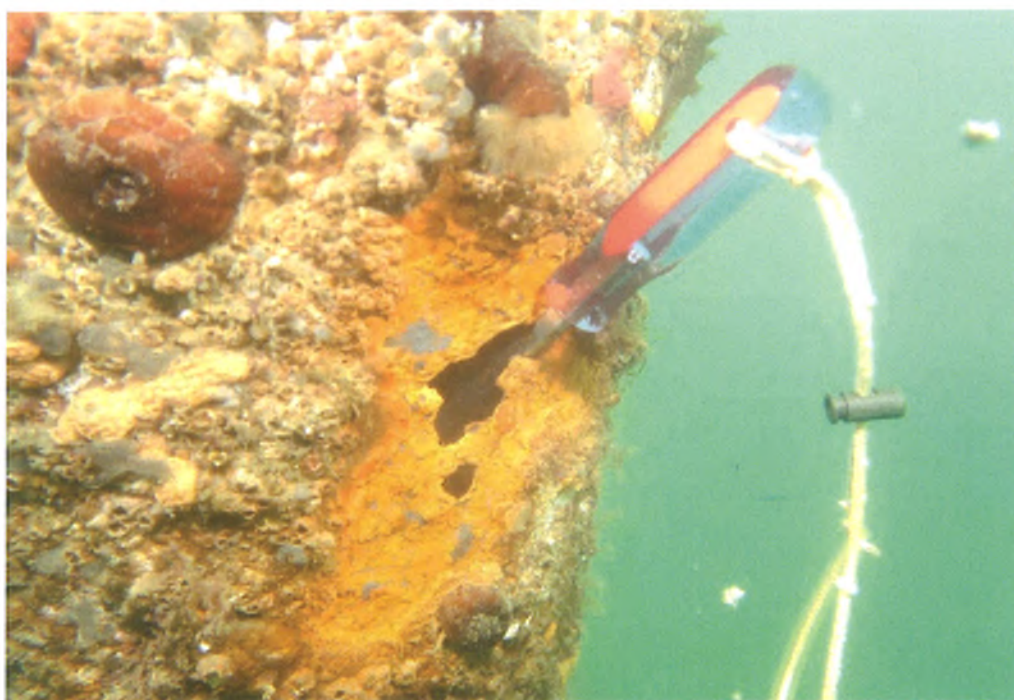
PHOTO No. 28: Breakwater, Pile A, Close-up – Note the screwdriver inserted into the approximate 2 inch diameter perforation. Also note the knife edge thickness around the perforation and the on-going active corrosion of the steel in this area.

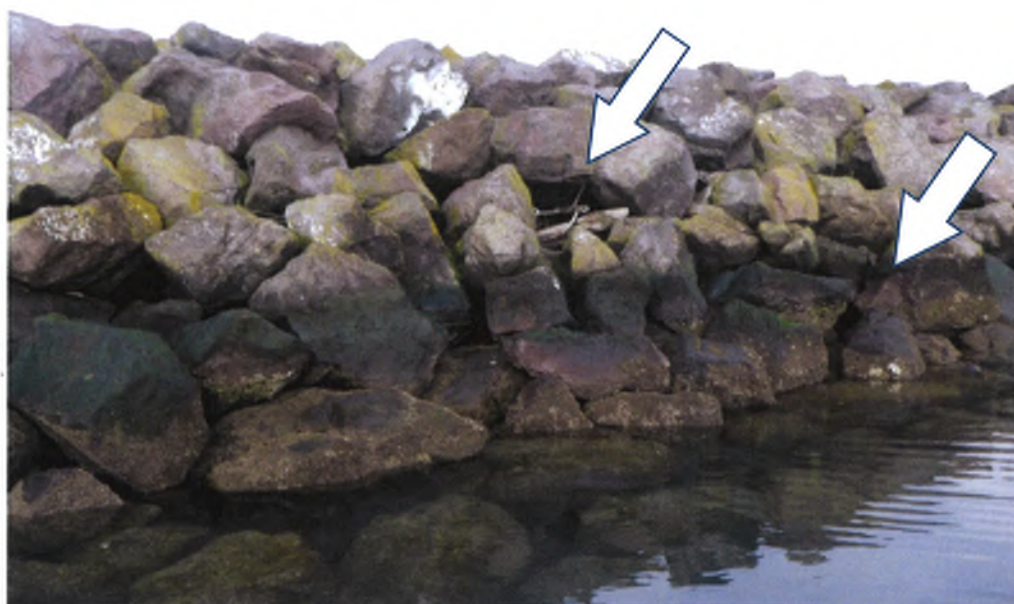
PHOTO No. 29: Breakwater, Typical Construction – Note the general, uniform placement of the armor stone along the upper, above water portion of the breakwater. The arrows indicate locations of minor irregularities or gaps in the stone, identified along the outer side of the Breakwater near the southern end.

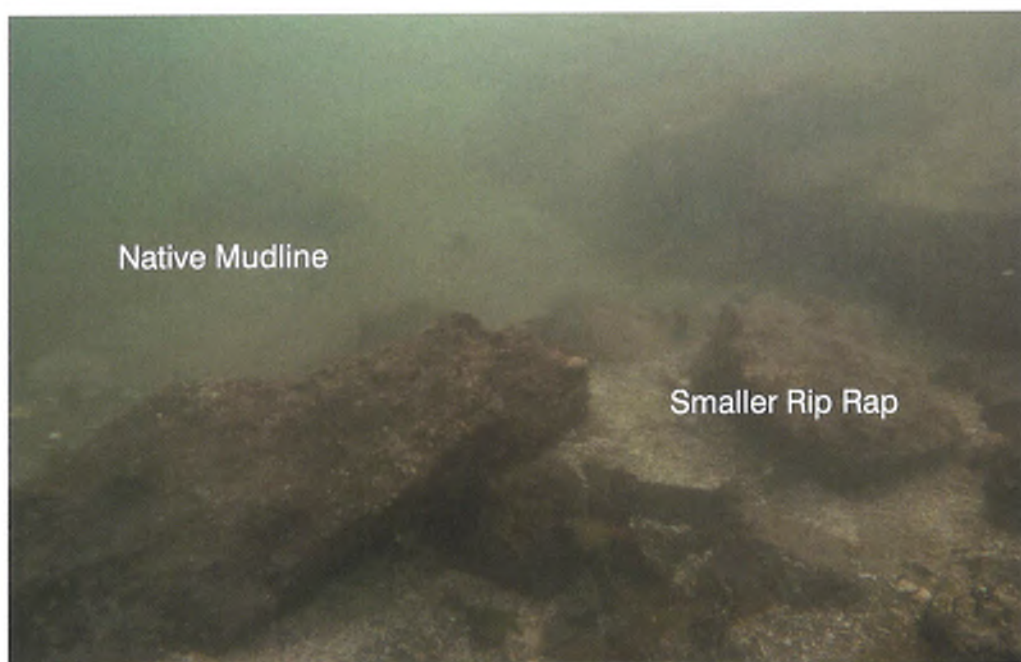
PHOTO No. 32: Breakwater, Outer Side, Near Pile D, Looking Southeast – Inspection noted that the outer side of the Breakwater slopes down from an intermediate shelf of sand and small rock with a smaller rip rap slope which extends to the native mudline.

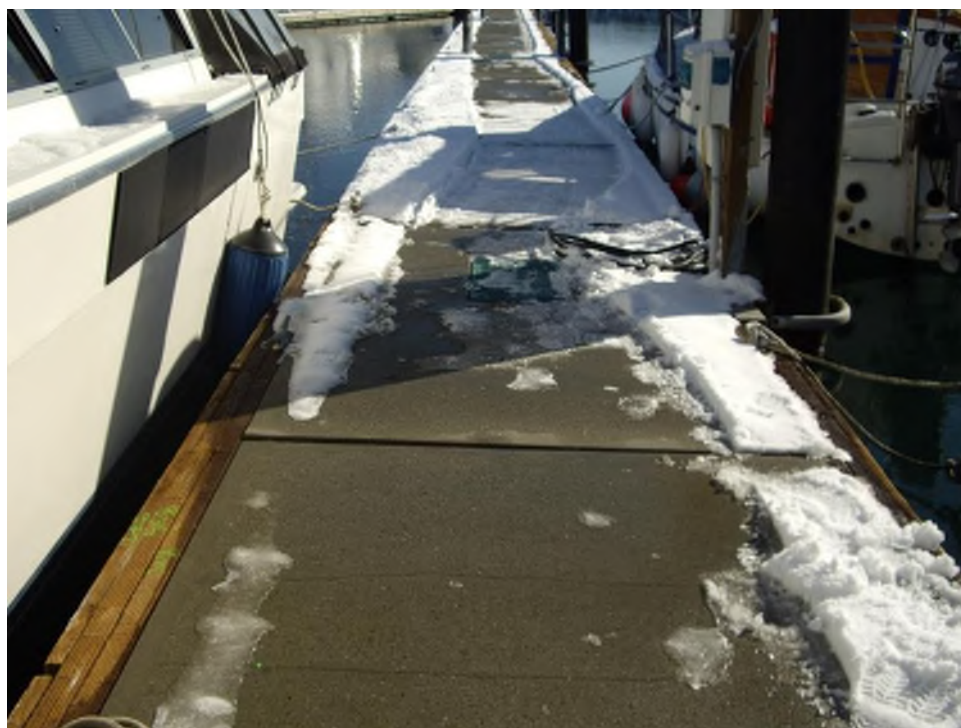
Figure 8. B Float Typical Waler & Concrete Float Condition
